Test Report

No.: GDGT-H/R-2021-0966

Applicant: Shenzhen SOFARSOLAR Co., Ltd.

Item	Product name	Product model	Product No.	QTY
1	Solar Grid-tied Inverter	SOFAR 50KTLX-G3-HV; (SOFAR 25KTLX-G3, SOFAR 30KTLX-G3, SOFAR 30KTLX-G3-A, SOFAR 33KTLX-G3, SOFAR 36KTLX-G3, SOFAR 40KTLX-G3, SOFAR 45KTLX-G3, SOFAR 50KTLX-G3, SOFAR 40KTLX-G3-HV, SOFAR 50KTLX-G3-HV) Note: These exterior products are the same, the difference is only the voltage parameters.	2021-0966-01	1

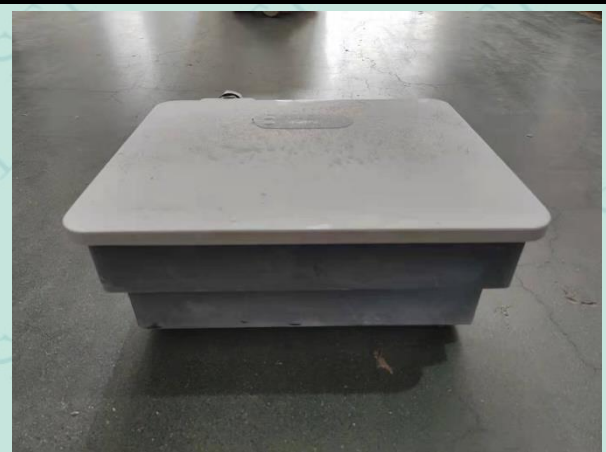
Fig 8 After the test

2. The sample was completed in accordance with the conditions, after the test, the appearance has no obvious change and there is no dust inside.

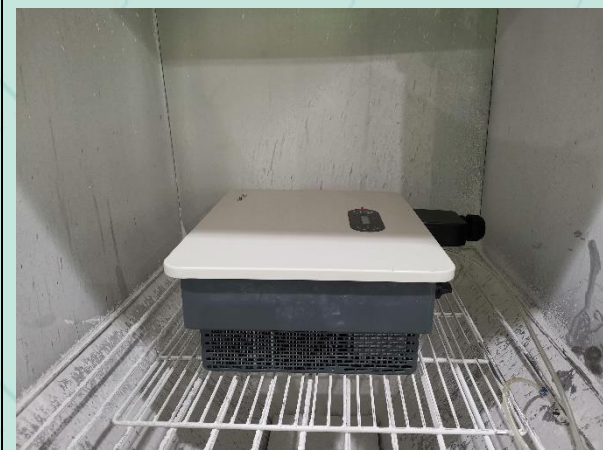
Fig 9 During the test (start)

1. Test dust type: Talcum powder;
2. Apply negative pressure;
3. With a maximum depression of 2 kPa;
4. The test time: 8h.

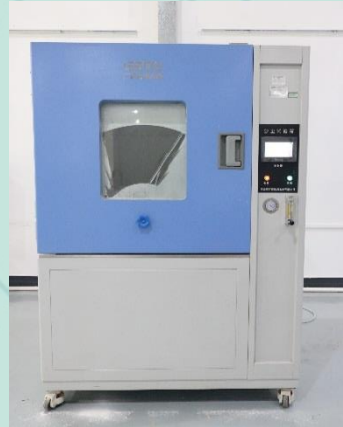
Fig 13 Test equipment

Equipment name	Equipment model	Serial No.	QTY	Validity period
Rain test device	YJ-IPX1-8	GDGS035	1	2021/12/11
Sand and dust test chamber	YJ-IP56X	GDGS036	1	2021/12/14

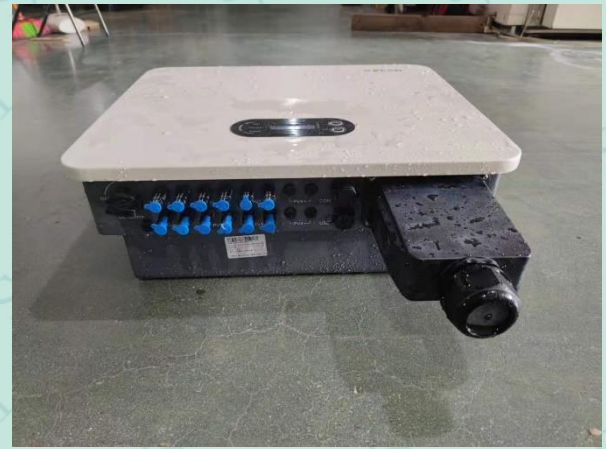
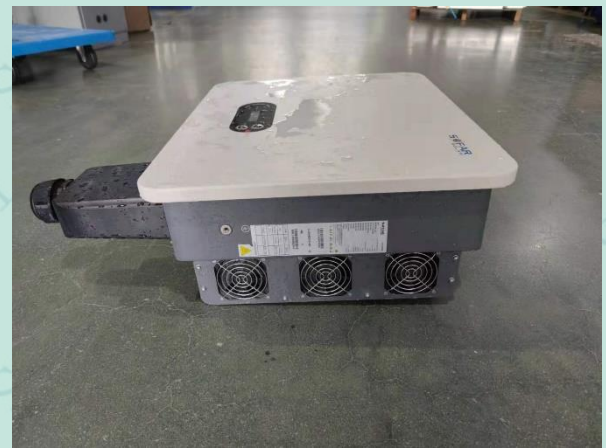
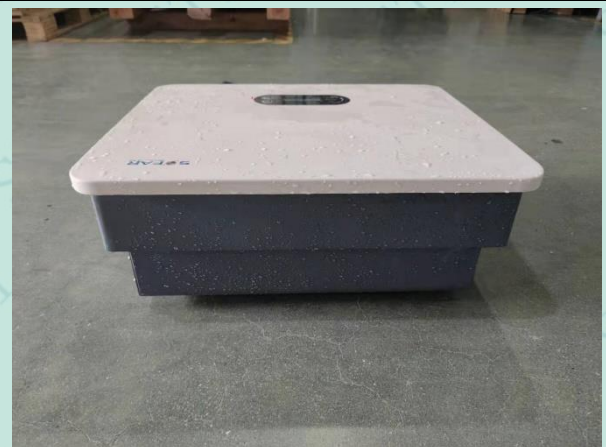
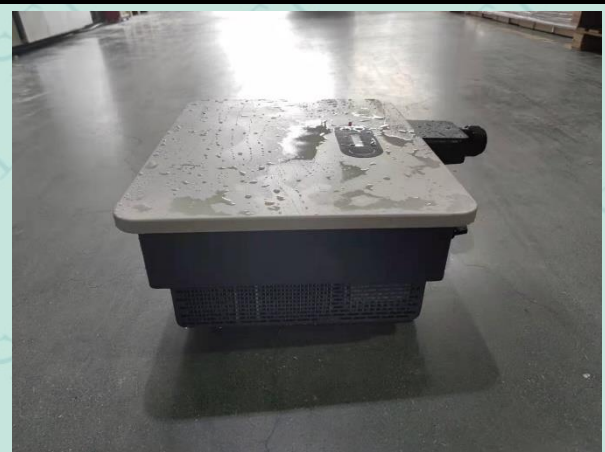
2. The test sample was completed in accordance with the conditions, after the test, the appearance has no obvious change and there is no water inside.

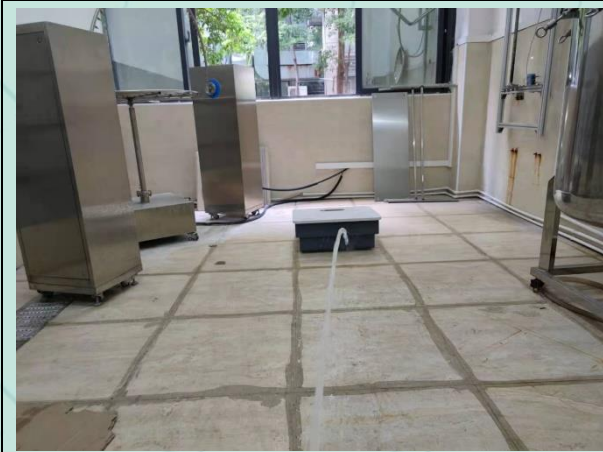
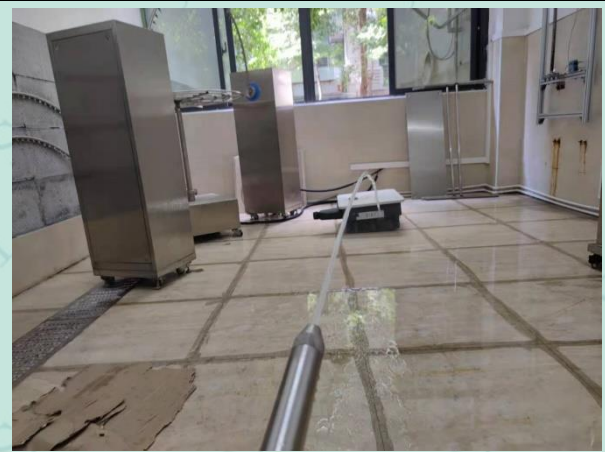
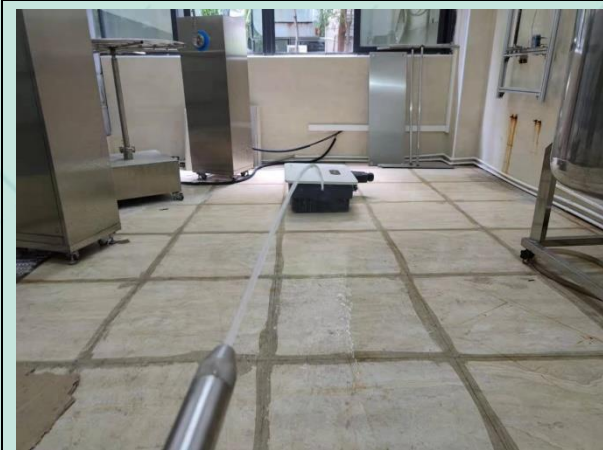
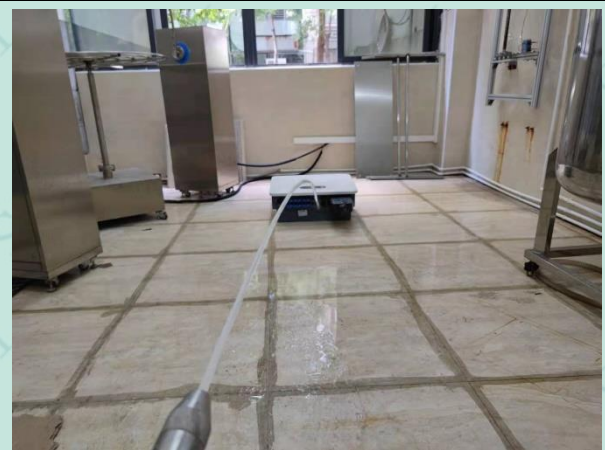
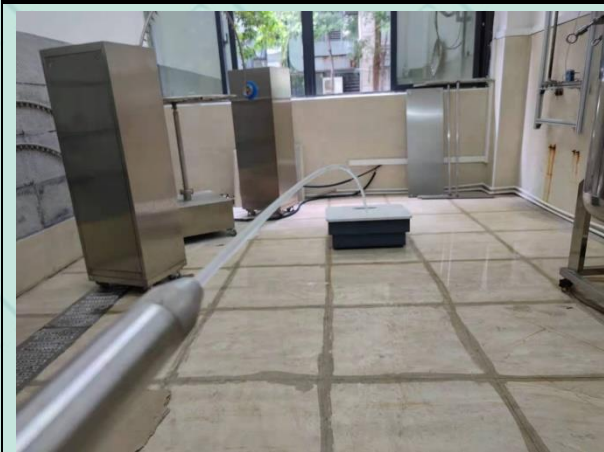
1. Internal diameter of the nozzle: 6.3mm;
2. Water flow rate: 12.5 ± 0.625 L/min;
3. Minimum test duration: Spraying time per square meter of the shell surface: $1 \text{ m}^2 / \text{min}$, the minimum test time is 3min;
4. Distance from nozzle to enclosure surface: between 2.5m and 3m.
